The above and following photos were captured from videotape of crash tests performed on April 6-7, 1999. Two identical 1996 Ford Taurus GL models were used in these tests. One vehicle had original manufacturer hood and fender; one vehicle had a CAPA certified hood and left fender installed.

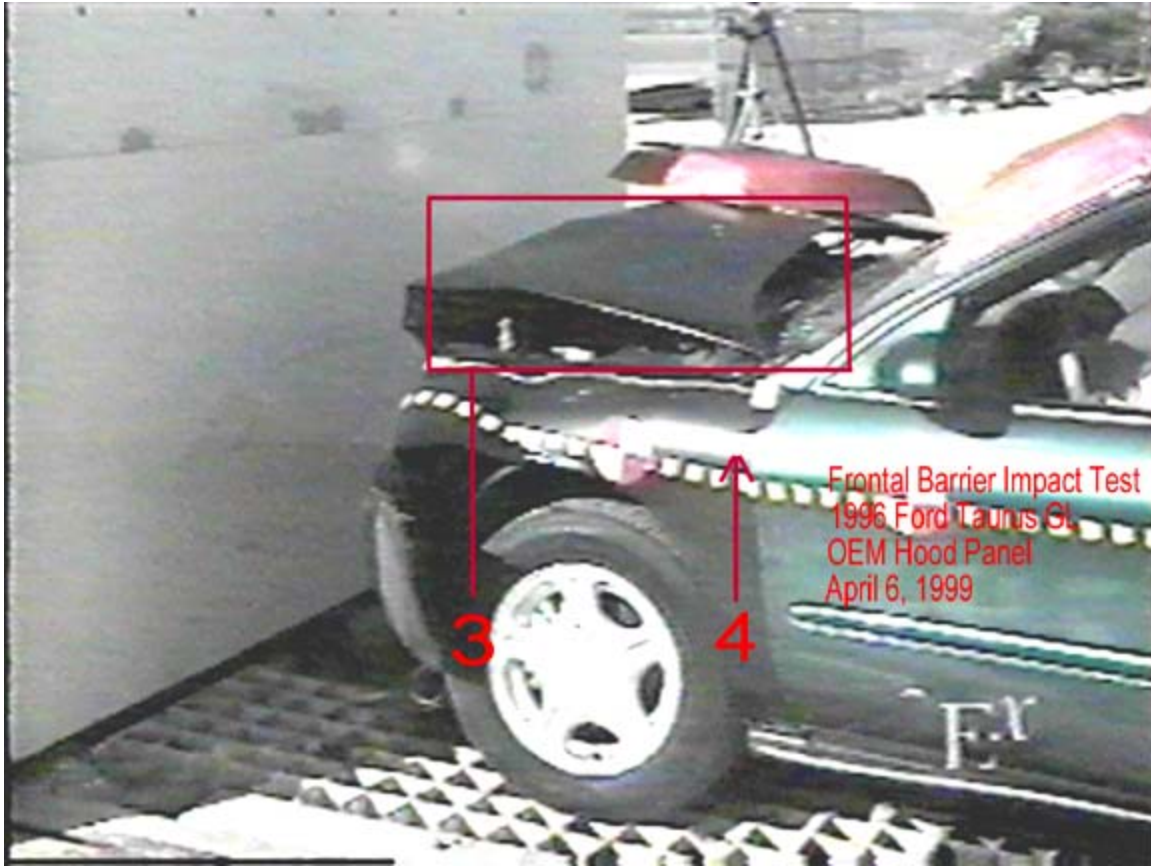
This photo is of the vehicle with OEM hood and left fender from the opposite side after impact. Note the sharp angles and relatively flat areas pictured (3), which indicate the factory designed “darts” performed as designed.

The left hinge area and rear fender (4) are consistent with the damage on the right side.
