Analysis of GM and CAPA Certified Grand AM Hoods & Fenders Comparison of Fit, Finish, Materials, & Assembly Characteristics

February 18, 2002

Tests conducted by General Motors Senior Quality Engineer and
General Motors Metal Fabrication Division Metallurgist

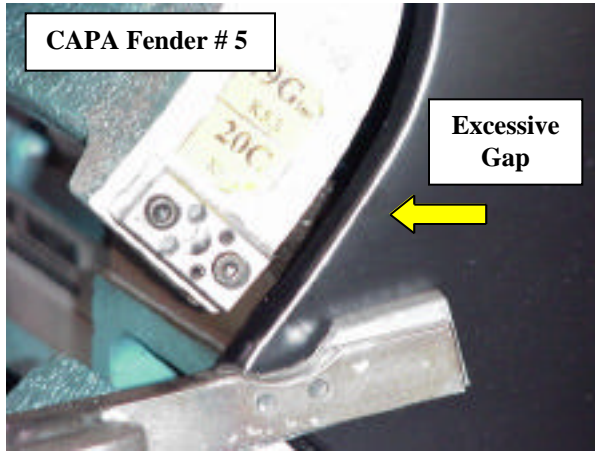
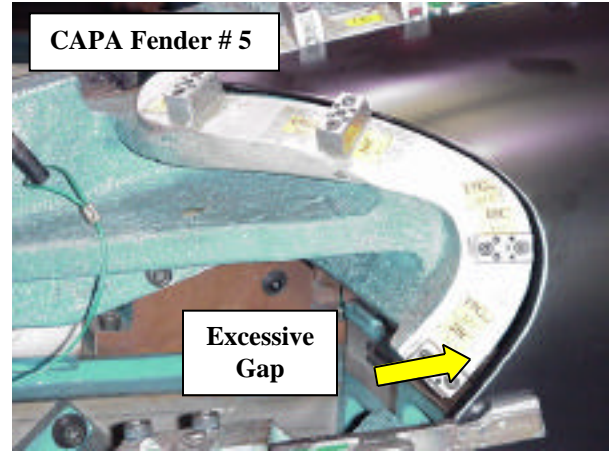
- Excessive gap at lower front of CAPA Fender # 5 (Reference Figure 1-A & 1-B)
- Nose not flush (high/outward with respect to mating component) on CAPA Fender # 6 (Reference Figure 1-C)

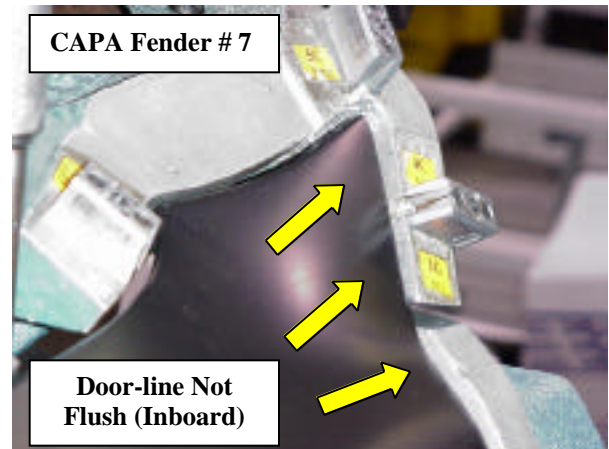
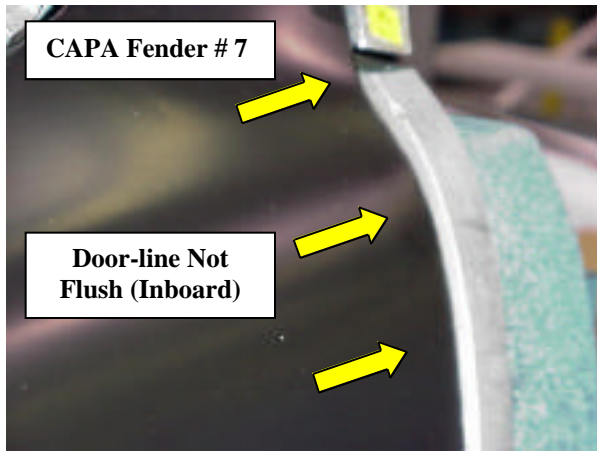
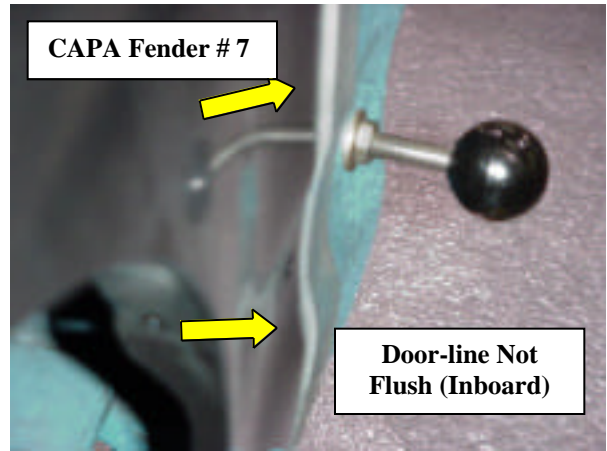
Figure 1-D

- Not flush along door-line (inward with respect to mating component), at rear of CAPA Fender # 7 (Reference Figures 1-D, 1-E, & 1-F)
- On the checking fixtures, most of the CAPA fenders required some extra force to clamp the part into car position. For example, the rear bottom section of CAPA Fender # 2 was forced down into position (Reference Figure 1-G)

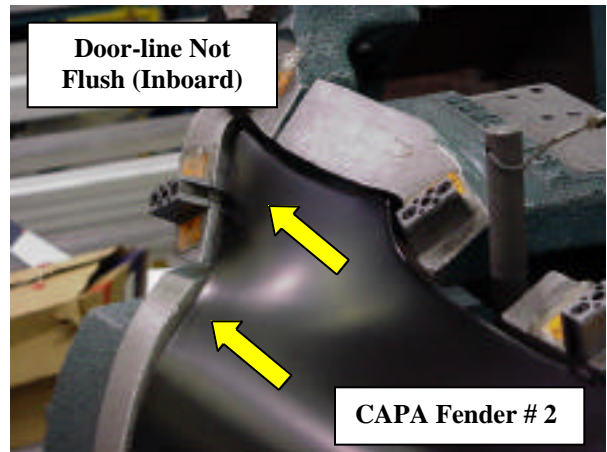
Figure 1-H

- Not flush at upper rear section (inward with respect to mating component) on CAPA Fender # 2 (Reference Figure 1-H)
- Not flush at rear (outward with respect to mating component), along door-line on CAPA Fender # 3 (Reference Figure 1-I)

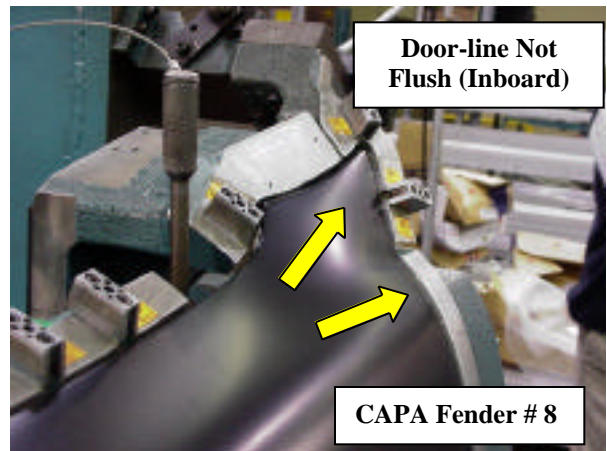
Figure 1-J

- Not flush at upper rear section (inward with respect to mating component) on CAPA Fender # 8 (Reference Figure 1-J)
- Nose not flush (high/outward with respect to mating component) on CAPA Fender # 8 (Reference Figure 1-K)

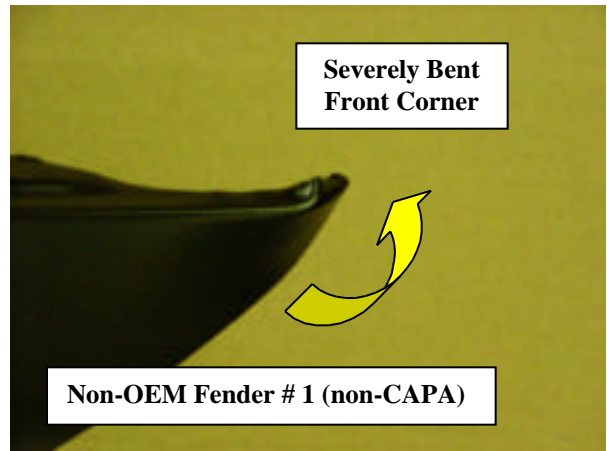
Figure 1-L

- Severely bent front corner (nose) on Fender # 1 (Reference Figure 1-L). This condition prevented part from fitting on the checking fixture, thus no data was collected. Because of severity, with no obvious primer disturbance, damage is suspected to have occurred prior to primer.

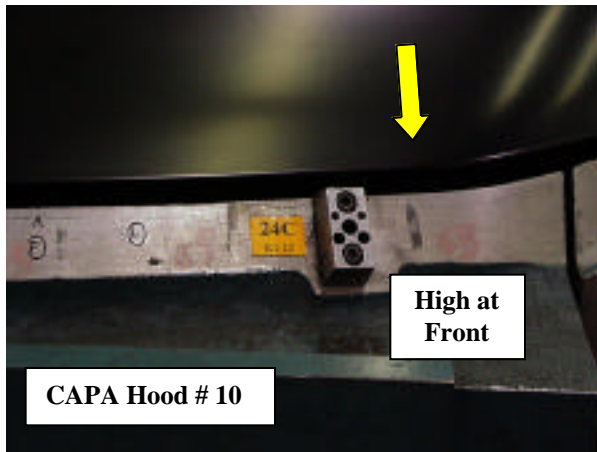
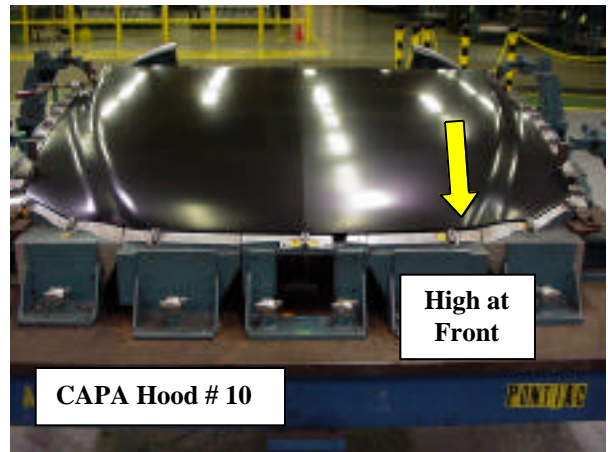
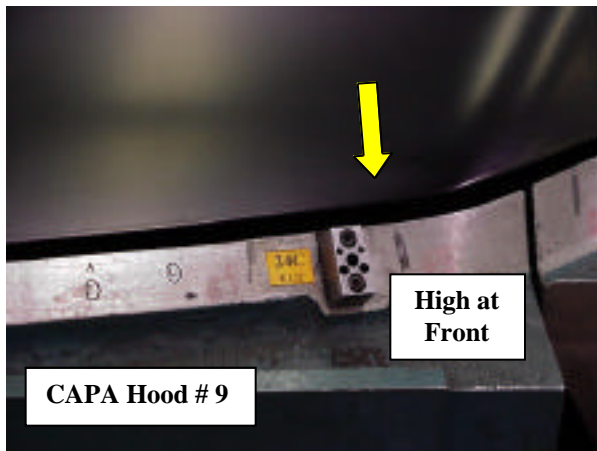
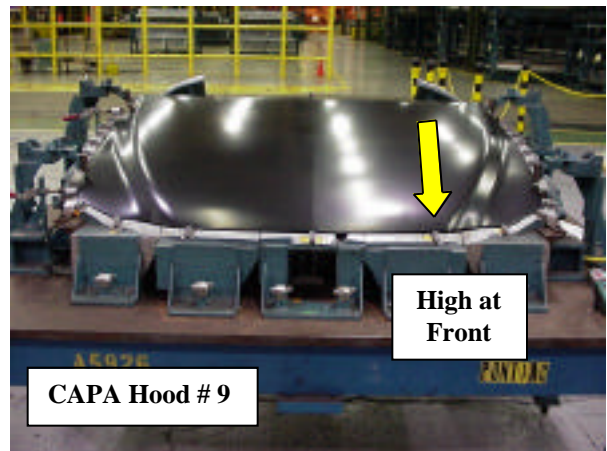
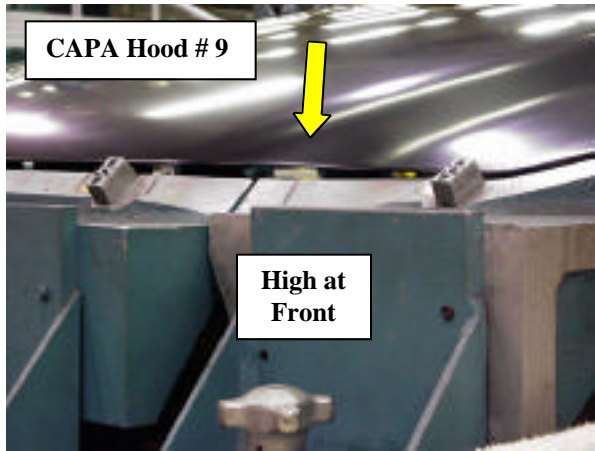
- All three CAPA hoods were high across the front, creating an unacceptable gap, on the driver side (Reference Figures 1-M & 1-N for CAPA Hood # 10; Figures 1-O & 1-P for CAPA Hood # 9; Figure 1-Q for CAPA Hood # 9)
- All three CAPA hoods were high at areas along the passenger side edge (Reference 1-R for CAPA Hood # 9)

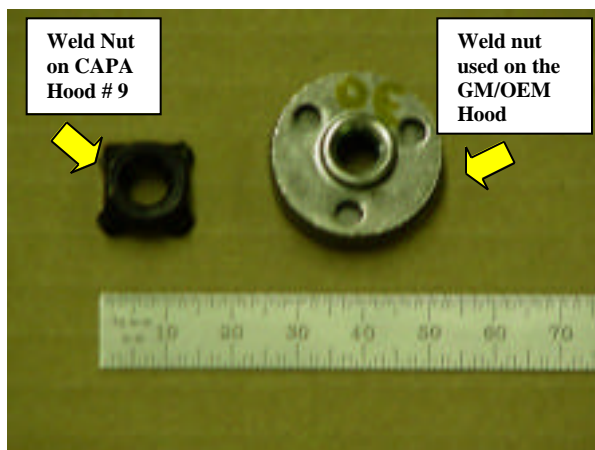
Figure # 2-A

- CAPA hood # 9 used different, smaller weld nuts on the Hood Primary Latch Striker Reinforcement, compared to those specified & used on the GM hood (Reference Figure 2-A)

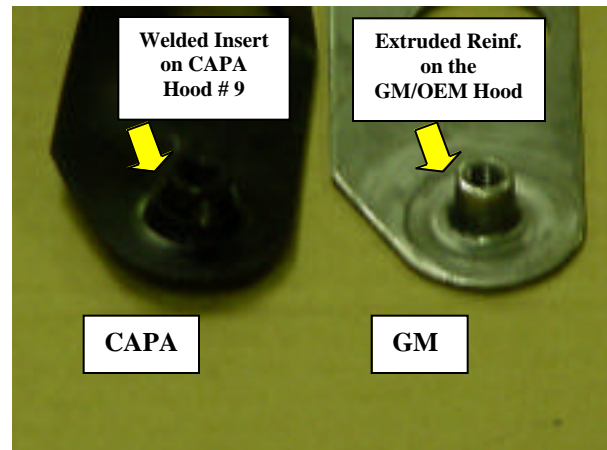
Figure # 2-B

- Hood Hinge Reinforcements were of different construction, having welded inserts at the threaded attachment points on all three CAPA hood assemblies, compared to the extruded reinforcements specified & used on the GM hood (Reference Figure 2-B)

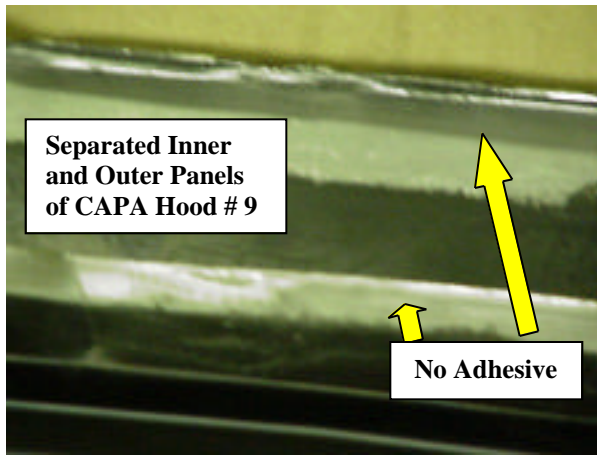
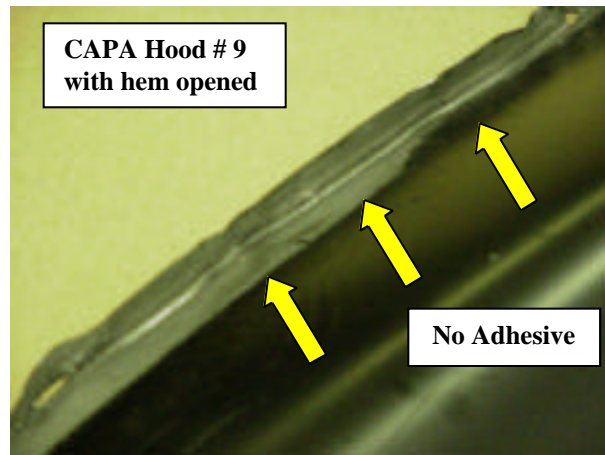
The CAPA certified hood assemblies were produced without adhesive between the hem. GM specifies and produces its hood assemblies with a two part adhesive that is applied to the full periphery of the hood outer panel before marriage with the inner assembly and hemming. **Components:** CAPA hood #9 exhibited different, smaller weld nuts (vs. GM specified), and hood hinge reinforcements were of different construction compared to the GM hood.

- Hem Periphery Adhesive was absent between the entire hem on the CAPA hood assemblies disassembled (# 9 & # 10) (Reference Figure 2-C which shows a separated inner & outer panel and Figure 2-D which shows an outer panel with the opened hem)

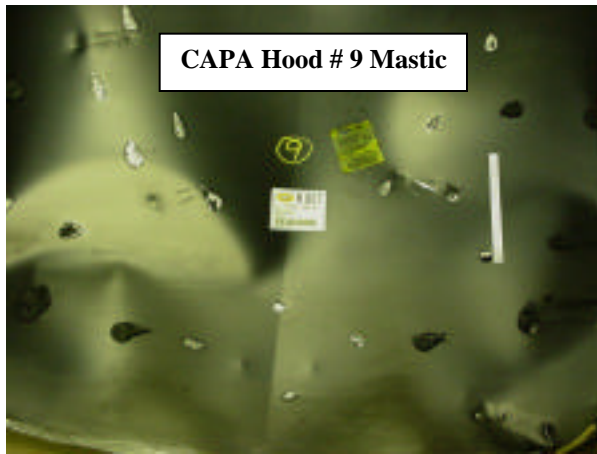
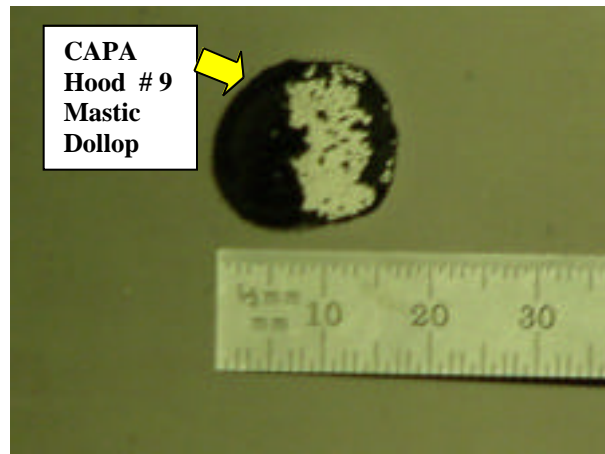
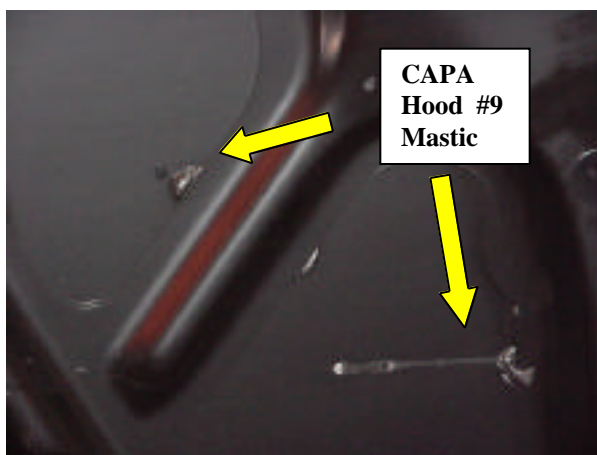
- Anti-Flutter Mastic was not present in the same locations and proportions, as compared to the application placement on GM products. This was discovered on the disassembled CAPA hoods # 9 & # 10. (Reference Figures 2-E, 2-F, & 2-G)

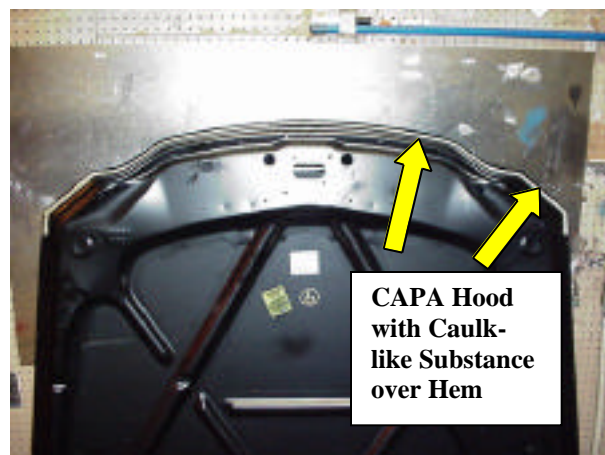
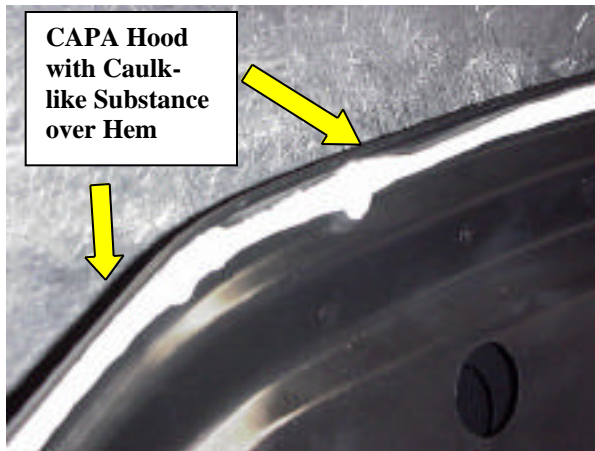
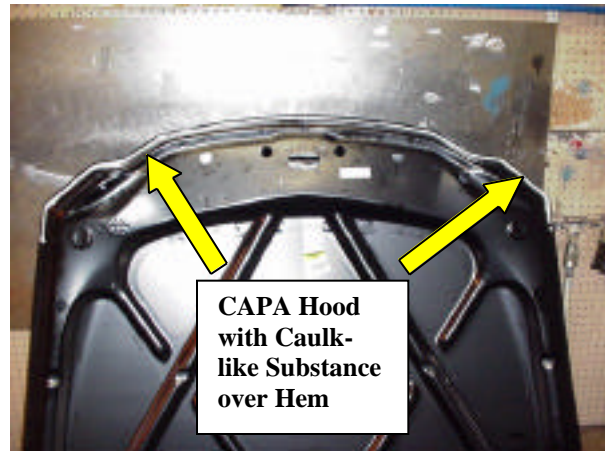
- A caulk-like substance was present over the hem, near the front, on all three CAPA hood assemblies (Reference Figures 2-H, 2-I, & 2-J). Note: This type of substance is not specified, nor present on the current GM hood.

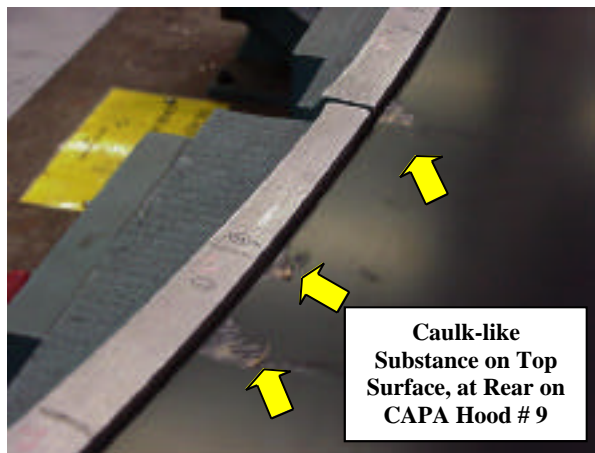
Figure 2-K

- A Caulk-like substance was present on the top surface, at the rear on CAPA hood # 9. The substance appears to be the same material present on the front hem (Reference Figure 2-K)

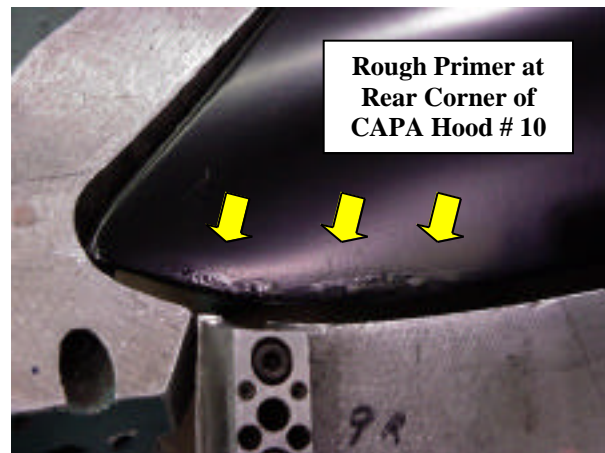
- Rough primer was present at the rear corners on the CAPA hoods (Reference Figure 2-L for CAPA hood # 10)

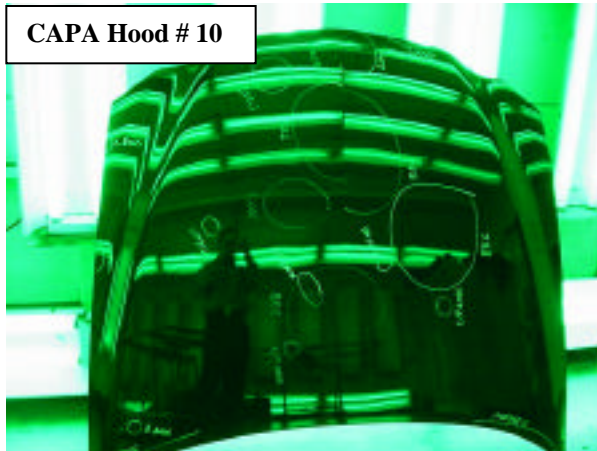
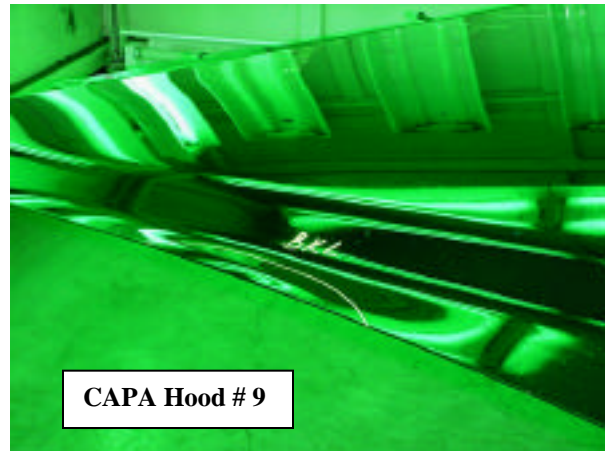
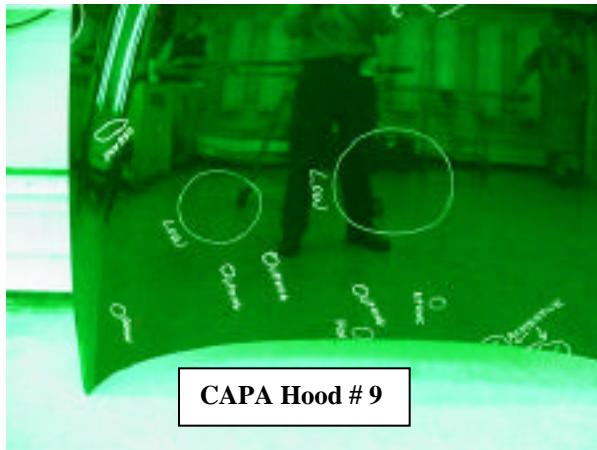
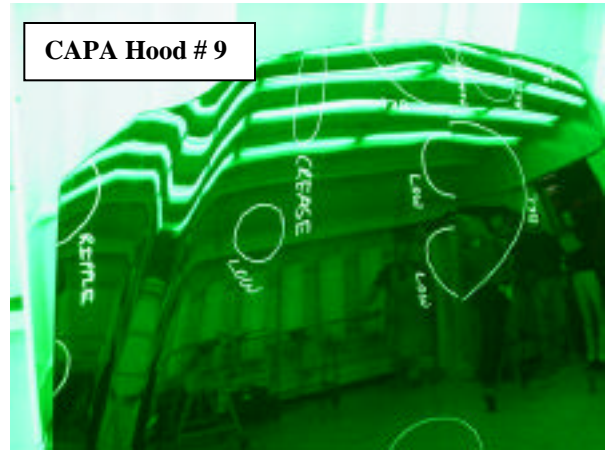
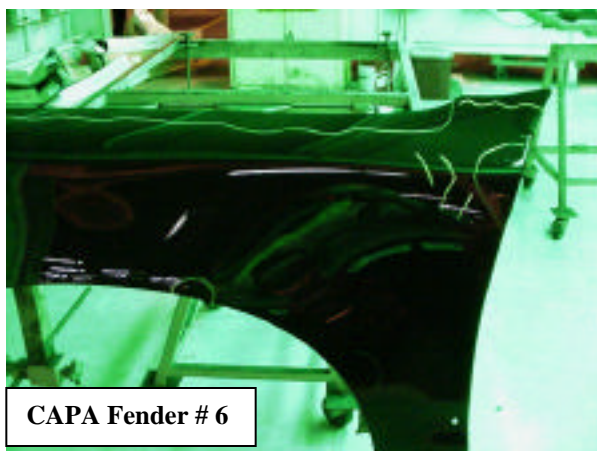
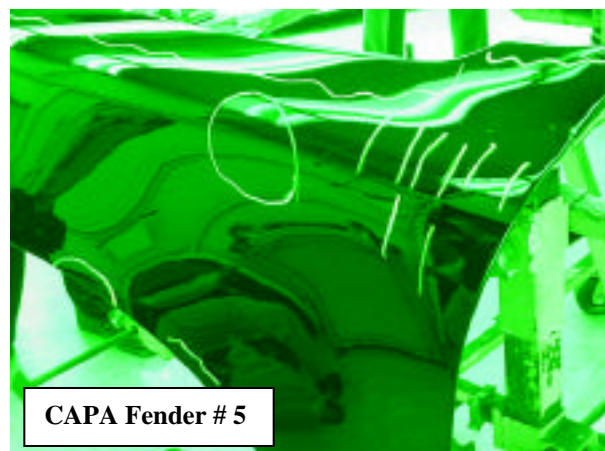
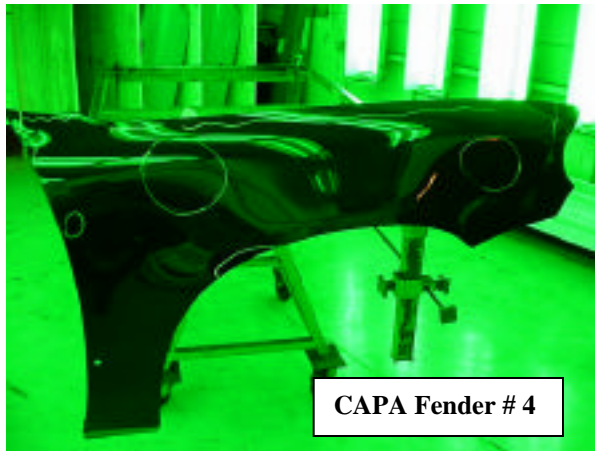
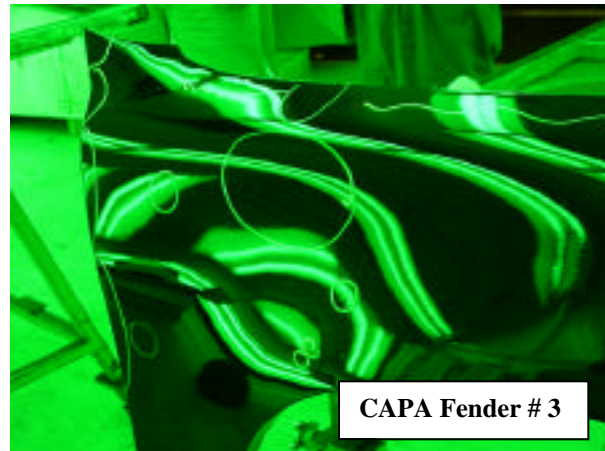
Appearance (pages 11 - 13) - The surface quality on the CAPA products is inferior compared to the surface quality on the GM products. Numerous surface defects were identified including buckles, creases, highs/lows, etc.

Surface quality was reviewed on the CAPA certified products at Lansing MFD on January 8, 2002. The CAPA hood assemblies and fenders were placed in a lighted inspection room to identify surface issues that are not present on the GM products. The inspectors who regularly monitor the GM products were asked to identify surface quality issues that would be unacceptable on the GM products. In this review, many different types of discrepancies were observed. The surface discrepancies consisted of highs, lows, up-dings, down-dings, buckles, creases, ripples, etc. The following photographs display CAPA Certified Parts with the discrepancies indicated:

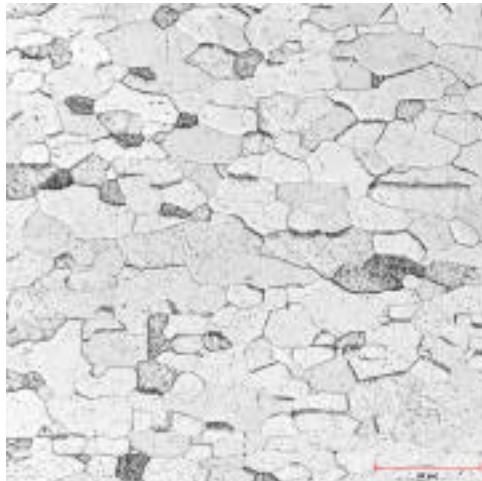
#9 Hood Outer

The chemistry of the bake hardenable steel creates a certain grain structure that provides dent resistance to the steel. The CAPA hoods do not have the proper grain structure of a bake hardenable steel.

Core structure of outer hood 500X
Dark areas are dark etching ferrite grains.

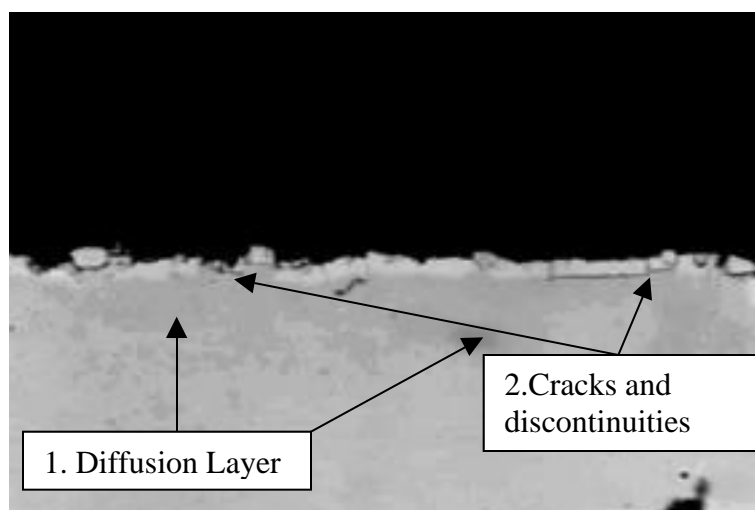
The #9 CAPA hood shows an out of specification condition at the interface with the base steel as shown in the picture below. The coating is also cracked, which is unacceptable in the GM specification.

As-polished #9 CAPA Hood Palm Print Sample. Thin coating layer at surface 1000X.
The coating layer appears to have been a diffusion layer (1) into the substrate material.

The #9 and #10 hood outers have a similar zinc coating with intermittent perpendicular crack-like discontinuities and intermittent discontinuities (2) in which there is a lack of coating. The coating appears to have flaked off or chipped away before the ELPO layer was applied.
