Analysis of GM and CAPA Certified Grand AM Hoods & Fenders Comparison of Fit, Finish, Materials, & Assembly Characteristics

February 18, 2002

Tests conducted by General Motors Senior Quality Engineer and
General Motors Metal Fabrication Division Metallurgist

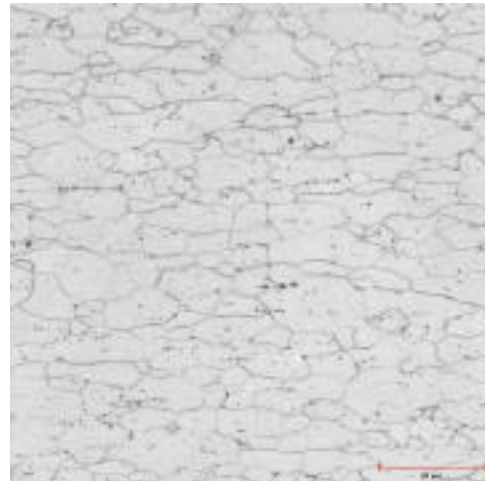
#9 Hood Outer

The GM OEM hood is ~40% stronger than the CAPA hoods. Both the #9 and #10 CAPA hoods in the strained condition (after forming) do not meet the GM engineering minimum strength requirement in the unformed sheet.

Core structure of outer hood 500X
Dark areas are dark etching ferrite grains.
